PROGRESS REPORT

PR 91570-510-12

For the Period of 1 June 1964, through 30 June 1964

DEVELOPMENT OF A HYDROGEN-OXYGEN SPACE POWER SUPPLY SYSTEM

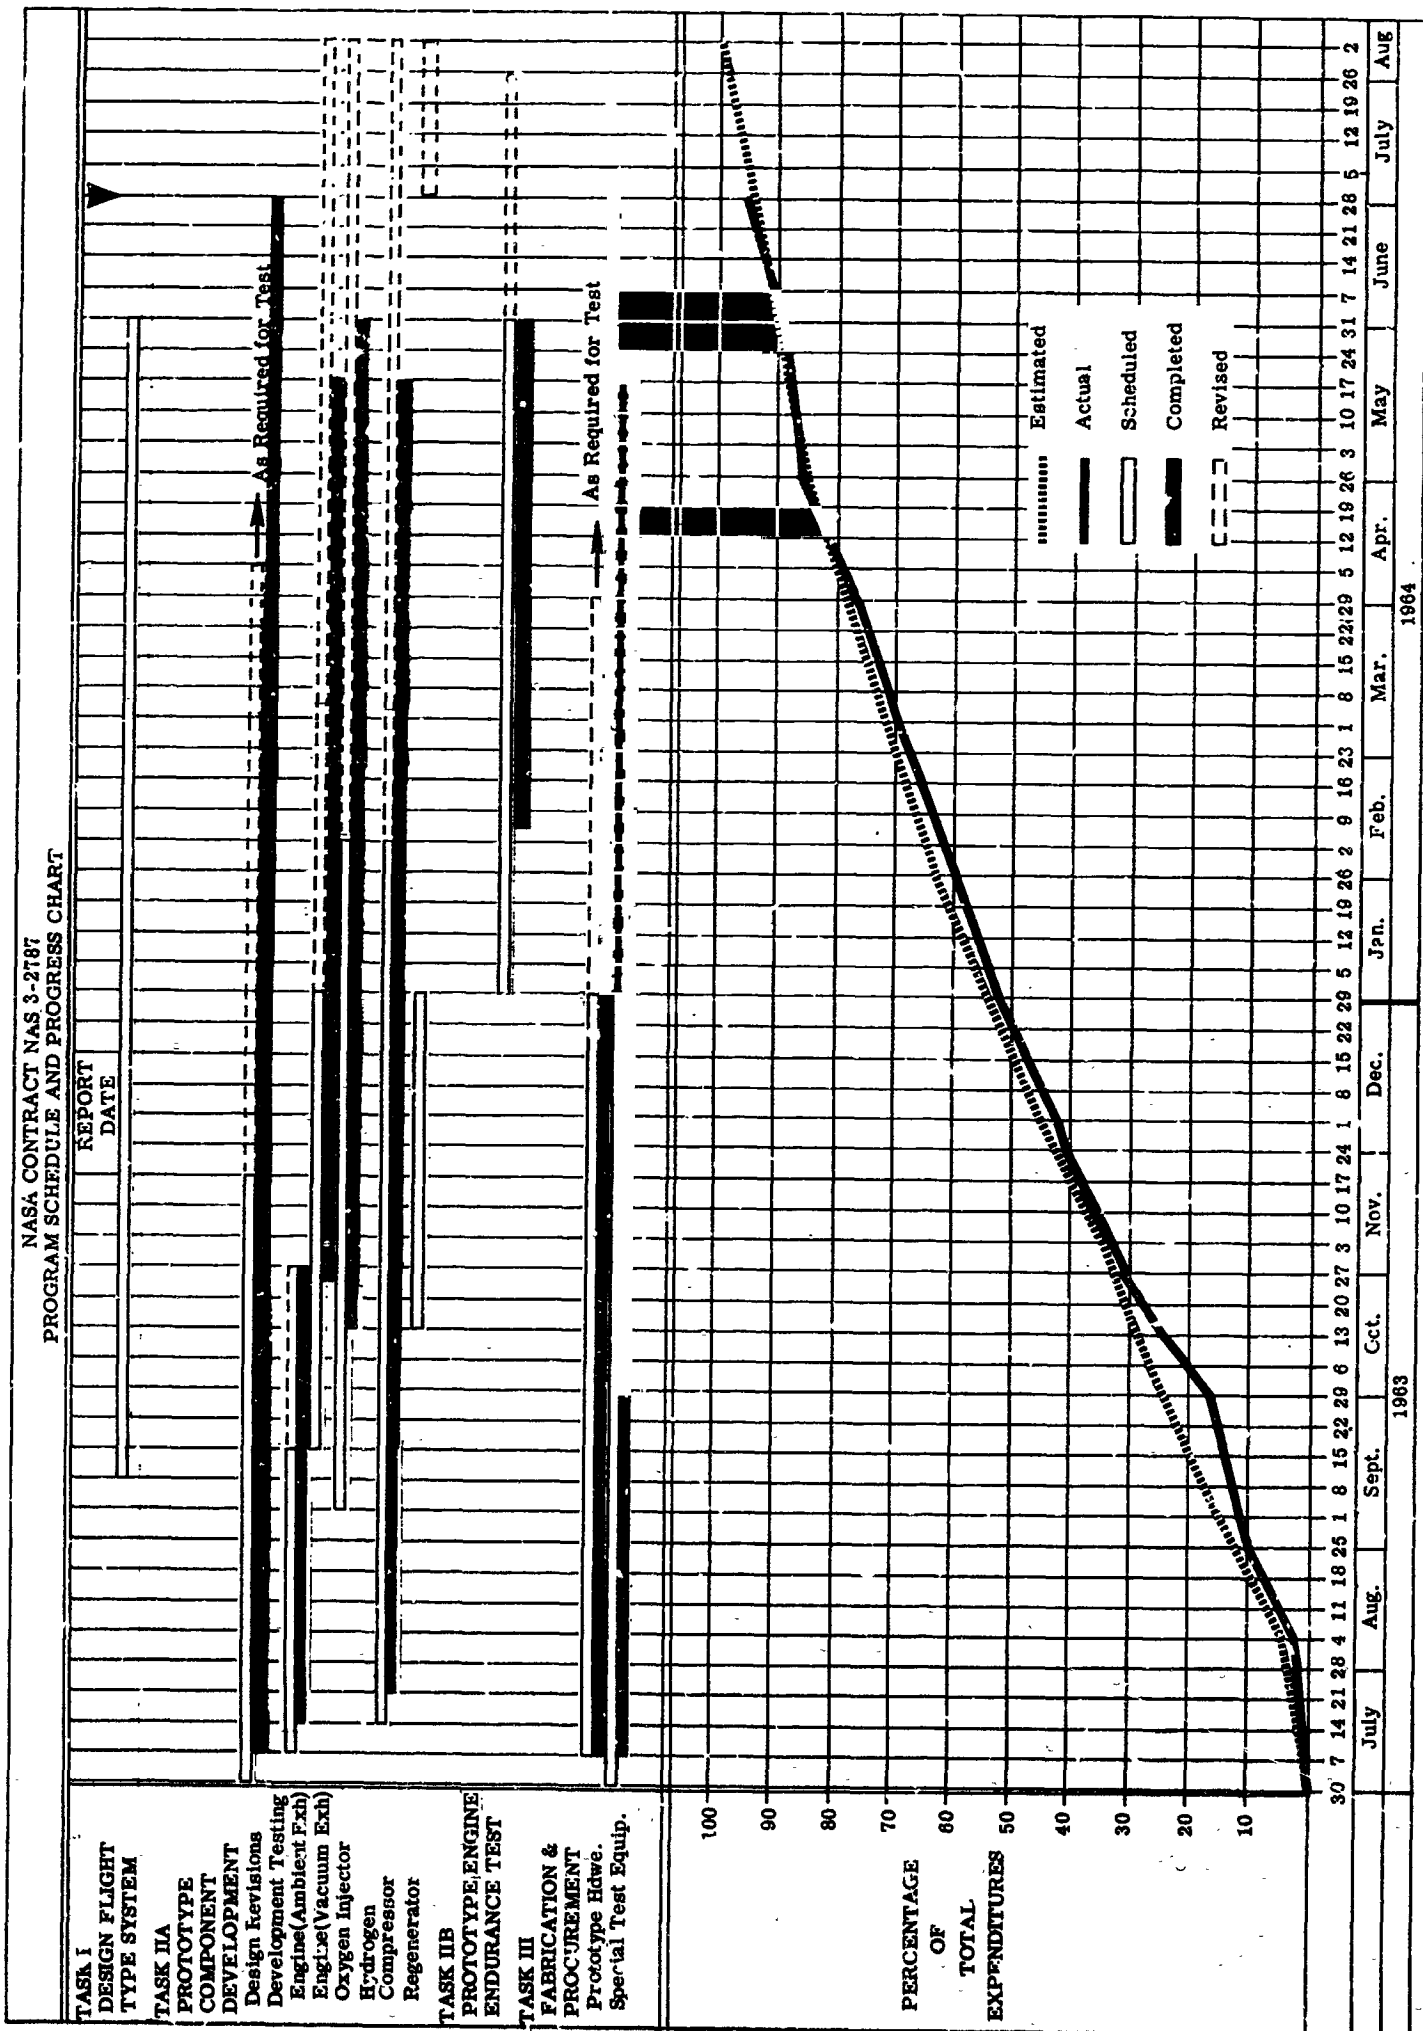
The program schedule shown in Fig. 1 has been revised to reflect changes in the program plans resulting from a technical review meeting between NASA and Vickers Inc. on January 16 and 17, 1964. Component development and endurance testing will be extended through July, 1964. Flight system design work will continue to be deferred until additional development and endurance testing have been accomplished.
